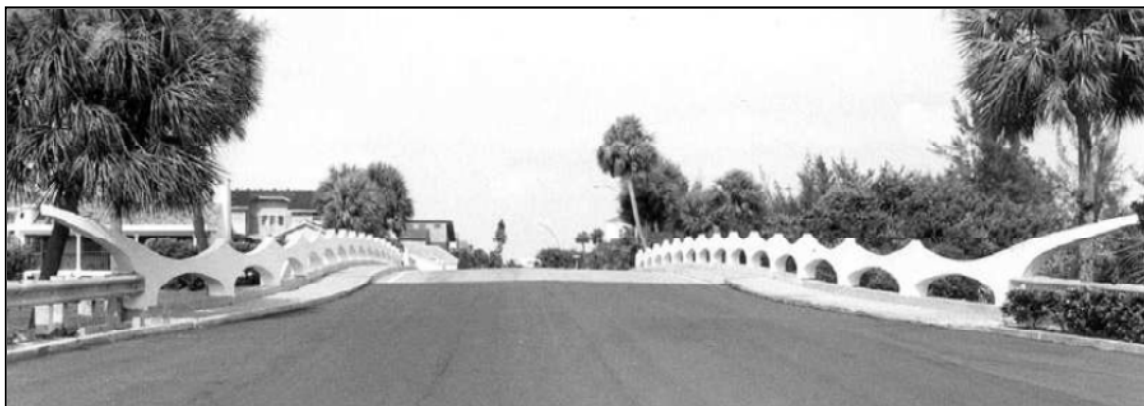
Photo 7-12. The 13th Street Bridge from its Western Approach.

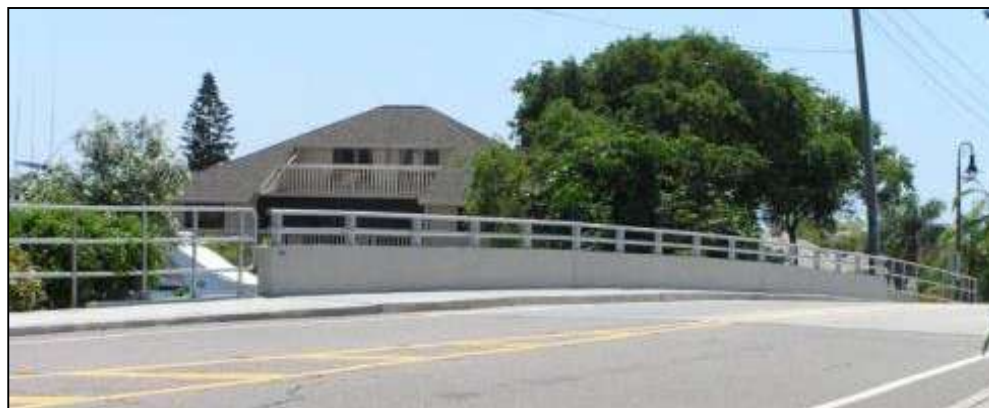
Photo 7-13. Madonna Boulevard Bridge with Replaced Railing, June 2010.

However, in 2005, the character-defining railings of both the Madonna Boulevard Bridge and the 13th Street Bridge were removed and replaced with a concrete wall topped with aluminum rails. **Photo 7-13** shows the new railing on the Madonna Boulevard Bridge. These dramatic alterations effectively destroyed the significance of each bridge, which derived their importance under NRHP Criterion C in the area of Architecture.

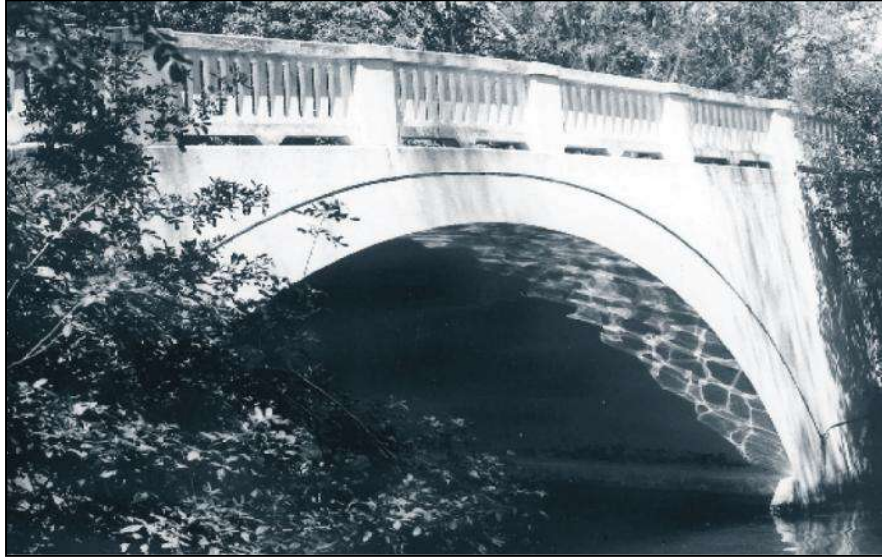
Photo 7-14. Original Appearance of the Granada Boulevard Bridge.

A similar fate has adversely affected the historic **Granada Boulevard Bridge** (No. 875306) which carries Granada Boulevard over the Coral Gables Canal in Miami-Dade County. The original 1930 concrete arch deck bridge, associated with the residential development of Coral Gables, featured a slotted cast concrete railing designed to give an appearance of greater length and style to the structure (**Photo 7-14**). The narrow, high, and pointed slots resulted in a distinctly different appearance than the oval slots used in standard design railings during the 1930s and later. In ca. 2005, the aesthetically pleasing railing was replaced with concrete posts and aluminum rails, thereby destroying the significant character-defining feature of the bridge which qualified the structure for listing in the NRHP under Criterion C in the area of Architecture. The Granada Bridge, shown with the non-historic rail in **Photo 7-15**, no longer meets the NRHP eligibility criteria.

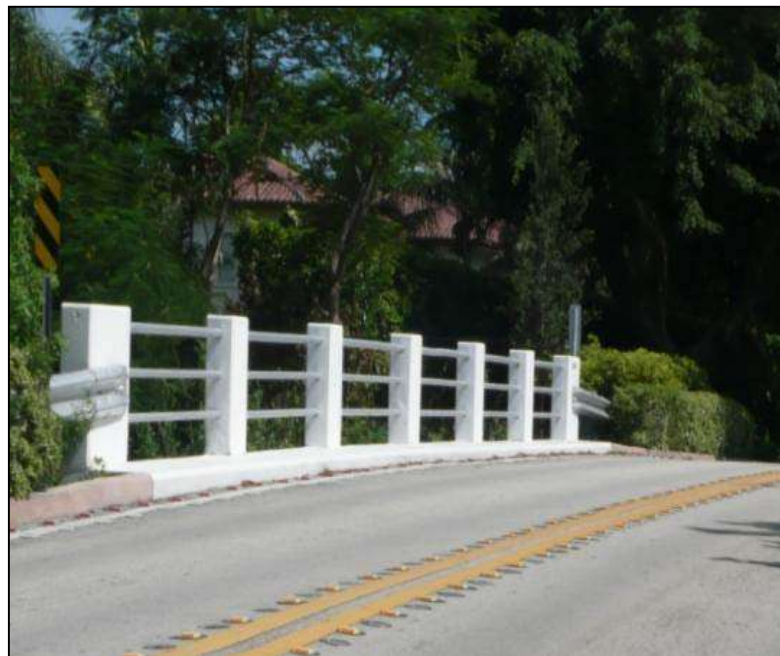
Photo 7-15. The Granada Boulevard Bridge with Replaced Railing, 2010.
