### **Culverts**

#### **County Road 18 Arch Culverts**

**Blackwater Creek Overflow  
Bridge**

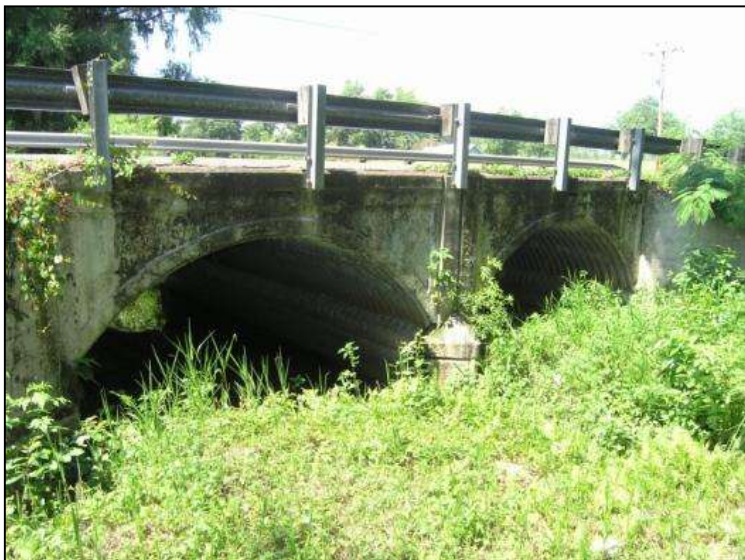
**Photo 5-48. CR-18 over Braggs Branch, Bradford County (No. 280036)**

The three unadorned 1940 corrugated steel arch culverts along CR-18 in Bradford County are interesting late examples of their type. In contrast to the arched, stone-faced New Deal era culverts, these three have smooth concrete facades. Their intermediate piers feature fluted boots to assist with water flow. Structure Nos. 280036 (**Photo 5-48**) and 280038 have two spans and measure 26 feet and 27 feet in

The corrugated steel arch culverts featured here represent a continuum in the design trends for its type but are also included for additional consideration as representatives that mark the end of a design paradigm. Due to their integrity, increasing rarity, and at-risk condition, the three culverts are noteworthy examples of their type. Further in-depth research may reveal that the 1940s arched culverts are associated with the WPA or CCC. They are newly recommended NRHP-eligible under

Criterion C in the area of Engineering as high integrity examples of corrugated steel arch culverts and good representatives of the culmination of a design trend for arched culverts witnessed through the 1940s.

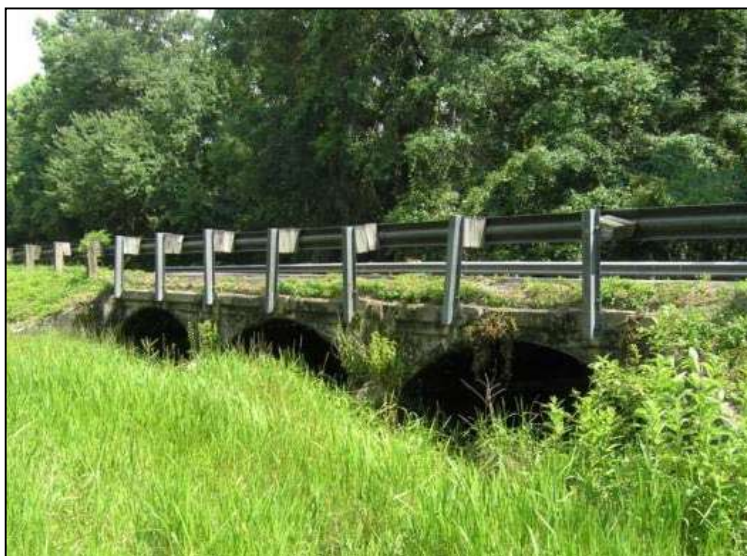
length, respectively. The three-span culvert over Gum Creek (No. 280037) (**Photo 5-49**) extends 43 feet.

**Photo 5-49. CR-18 over Gum Creek, Bradford County (No. 280037)**

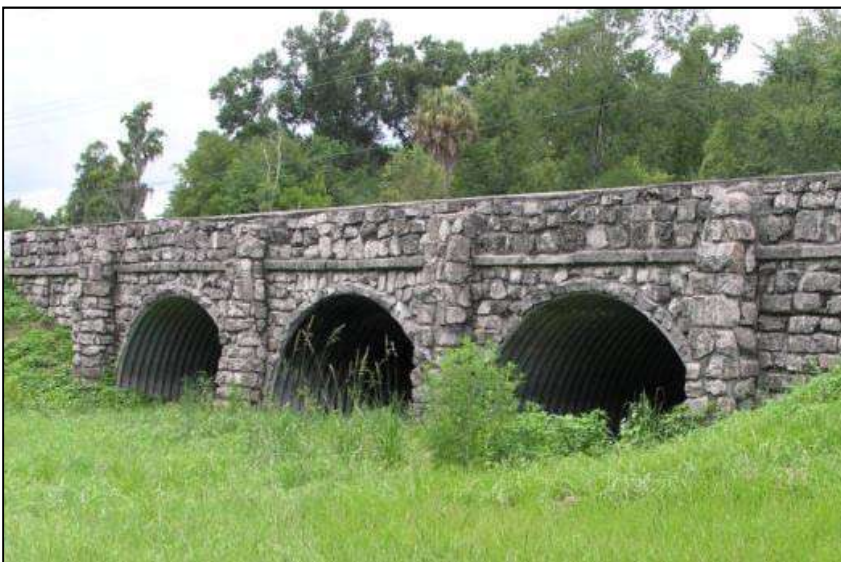
This steel arch culvert carries SR-39 over the overflow of Blackwater Creek in Hillsborough County. The culvert is supported by three corrugated steel arches, and its sides are faced with local stone rubble. This structure is estimated to have been constructed circa 1936, probably as part of a public work program; however, the actual date of construction is unknown. It is similar in

**Photo 5-50. Blackwater Creek Relief Structure, Hillsborough County (No. 100647)**

appearance to others that appeared in literature of the period, such as *Florida Public Works*. Corrugated steel was frequently used in the 1930s. While the design and construction were common throughout Florida at the time, this culvert is the only remaining example of its type in west-central Florida.

The Blackwater Creek Overflow Bridge was determined eligible for listing in the NRHP by the Florida SHPO in 1993. It is significant under Criterion A in the area of Community Planning and Development due to its association with the expansion of paved roads to link rural communities, and under Criterion C in the area of Engineering as a unique structure in an inland rural Florida landscape.<sup>118</sup>

Prior to rehabilitation in 2002, the structure was documented to HAER Level II standards. Carried out in accordance with the Secretary of the Interior's Standards, rehabilitation included the use of in-kind materials on the facades, and retention and re-use of as much of the original concrete rubble and granite block veneer facades as possible. During this process, the stone rubble was removed and replaced piece by piece.<sup>119</sup> The elevations of the culvert retain their historic physical integrity.
